DEPARTMENT OF TRANSPORTATION**DIVISION OF ENGINEERING SERVICES**

Contract #: 04-0120F4Cty: SF/ALA Rte: 80 PM: 13.2/13.9File #: 69.28**WELDING INSPECTION REPORT****Resident Engineer:** Siegenthaler, Peter**Address:** 333 Burma Road**City:** Oakland, CA 94607**Report No:** WIR-017721**Date Inspected:** 26-Oct-2010**Project Name:** SAS Superstructure**OSM Arrival Time:** 700**Prime Contractor:** American Bridge/Fluor Enterprises, a JV**OSM Departure Time:** 1900**Contractor:** Zhenhua Port Machinery Company, Ltd (ZPMC), Changxing Island **Location:** Shanghai, China**CWI Name:** Mr. Qiu Wen.**CWI Present:** Yes No**Inspected CWI report:** Yes No N/A**Rod Oven in Use:** Yes No N/A**Electrode to specification:** Yes No N/A**Weld Procedures Followed:** Yes No N/A**Qualified Welders:** Yes No N/A**Verified Joint Fit-up:** Yes No N/A**Approved Drawings:** Yes No N/A**Approved WPS:** Yes No N/A**Delayed / Cancelled:** Yes No N/A**Bridge No:** 34-0006**Component:** Tower and Orthotropic Box Girder (OBG)**Summary of Items Observed:**

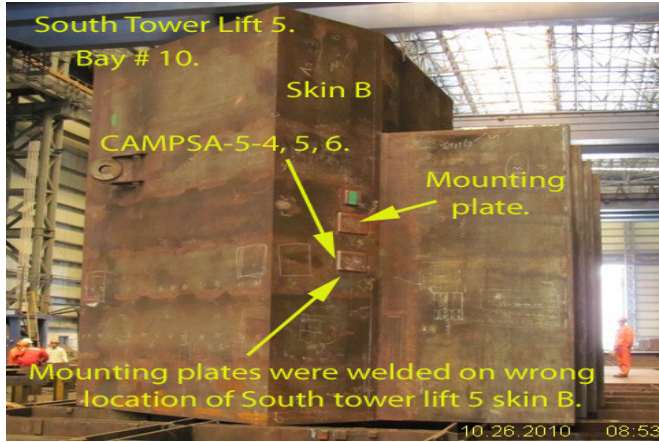
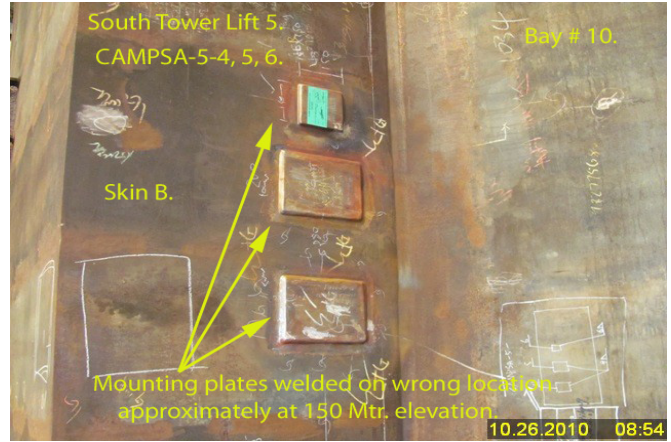
During random visual inspection in Bay 10, this Quality Assurance Inspector (QA) discovered the following issue: Three (3) mounting plates were welded at wrong locations on South Tower, Lift 5, Skin 'B'. As per the approved shop drawing mounting plates should be on tower saddle grillage at approximately 159m elevation. These plates were located at approximately 150m elevation. The fillet welds are identified as CAMPSA-5-4, 5, 6. The member is located in Bay#10. For further information, please see the attached pictures. This QA Inspector generated incident report for this date.
